DEPARTMENT OF TRANSPORTATION

Quality Assurance and Source Inspection

Contract #: 04-0120F4Cty: SF/ALA Rte: 80 PM: 13.2/13.9File #: 1x.28**WELDING INSPECTION REPORT****Resident Engineer:**Pursell, Gary**Address:** 333 Burma Road**City:** Oakland, CA 94607**Report No:** WIR-012839**Date Inspected:** 25-Mar-2010**Project Name:** SAS Superstructure**OSM Arrival Time:** 1200**Prime Contractor:** American Bridge/Fluor Enterprises, a JV**OSM Departure Time:** 1730**Contractor:** American Bridge/Fluor Enterprises, a JV**Location:** Job Site**CWI Name:** Tom Pasqualone**CWI Present:** Yes No**Inspected CWI report:** Yes No N/A**Rod Oven in Use:** Yes No N/A**Electrode to specification:** Yes No N/A**Weld Procedures Followed:** Yes No N/A**Qualified Welders:** Yes No N/A**Verified Joint Fit-up:** Yes No N/A**Approved Drawings:** Yes No N/A**Approved WPS:** Yes No N/A**Delayed / Cancelled:** Yes No N/A**Bridge No:** 34-0006**Component:** OBG Sections**Summary of Items Observed:**

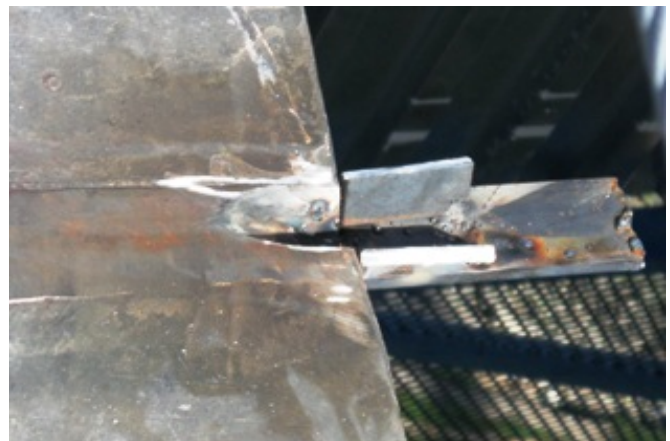
This QA Inspector observed QC Inspector Bernard Docena was present at weld joint E1/E2-D with ABF welding personnel Rory Hogan #3186 and Jeremy Dolmad #5042. The QA Inspector had previously been informed by QA Inspector Rick Bettencourt the welding personnel at this location had been having issues with porosity entering the weld metal. The QA Inspector was present this afternoon during welding and observed the issue with porosity in the weld had continued to be a problem. Approximately 300 mm of Flux Cored Arc Welding (FCAW) was performed in the overhead position. It appeared the entire length (300 mm) contained a large amount of porosity. This QA Inspector was present when ABF welding personnel Dan Ieraci #3232 confirmed the following with welding personnel Rory Hogan #3186 and Jeremy Dolmad #5042: The filler metal had been replaced with a new roll of wire, it had been verified the shielding gas lines were free of any kinks/obstructions that would prevent gas flow, the control cable from the wire feed unit "whip" had been replaced and the proper amount of flow was present at the welding touch. Dan Ieraci stated the next step should be to replace the current gas cylinder with a new cylinder and replace the current wire feed unit with a new one. The QA Inspector did not observe any further welding at this location this date.
